# **Athletic and Recreation Facilities Condition Assessment and Usage Report Towns of Hamilton and Wenham, MA**

**M a y 2 , 2 0 1 2**

## **ATHLETIC AND RECREATION FACILITIES CONDITION ASSESSMENT AND USAGE REPORT**

### **TOWNS OF HAMILTON AND WENHAM, MA**

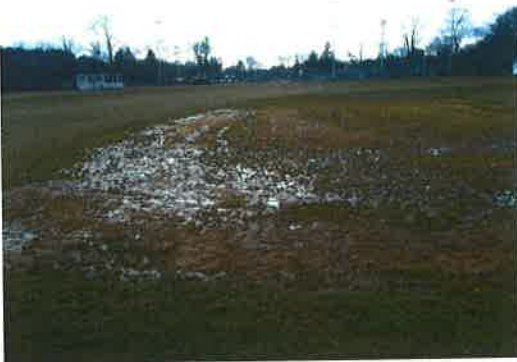
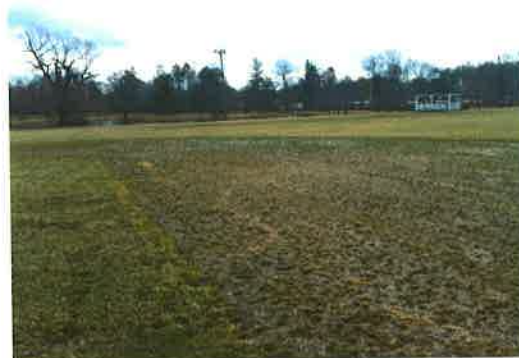
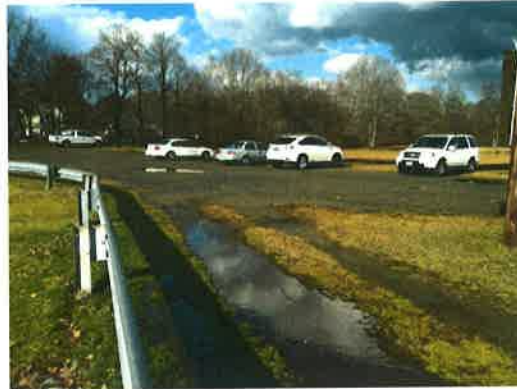
- B. Photo Documents (Insert pertinent photos here):

- b. General condition/effectiveness: Appears to be several standing water/ponding concerns in left field

Fair to poor growth density/turf cover. Several significant depressions, slow-  
draining areas in outfield. Turf condition is worn/bare in several areas and  
has poor root growth development. Field requires aeration to relieve  
compaction, topdressing, fertilizer, re-seeding, re-growth to achieve adequate  
turf cover and drainage through soils. Onsite soils are of moderate draining  
capabilities. Infield needs to be reconstructed, supplemented with good  
infield mix with adequate ratios of silt/sand to promote drainage. General  
maintenance to include weed removal, reconstruction of mound.

Field appears to be in fair to poor condition. Over-compaction, depressions  
creating standing water, slow draining soils in outfield areas. Recommend  
aeration to relieve compaction, topdressing, re-seeding, fertilizing, and re-

- c. Recommendations:  
Aerate to reduce compaction, installation of flat panel drain system
- 3. Sports Lighting **No**
  - a. Describe system (make/model; age; type poles; controls; coverage; condition):

growth to promote good root zone development. Recommend supplemental  
infield mix and weed removal.

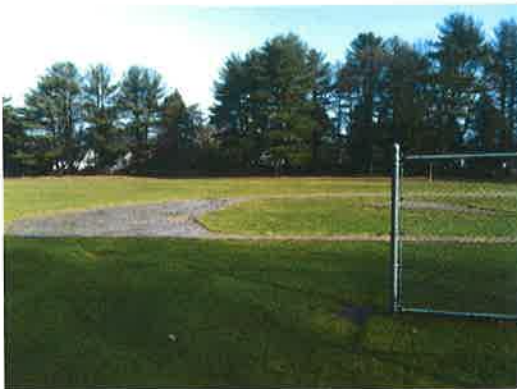
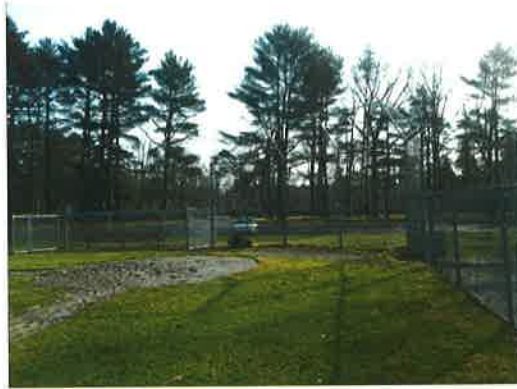
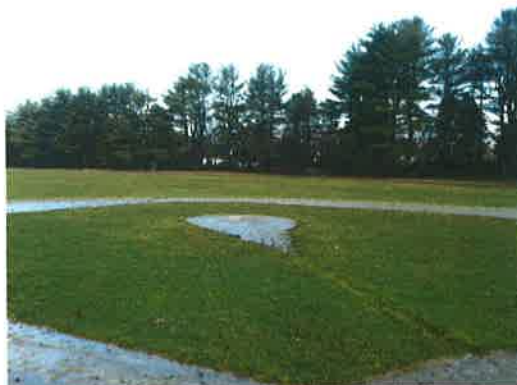
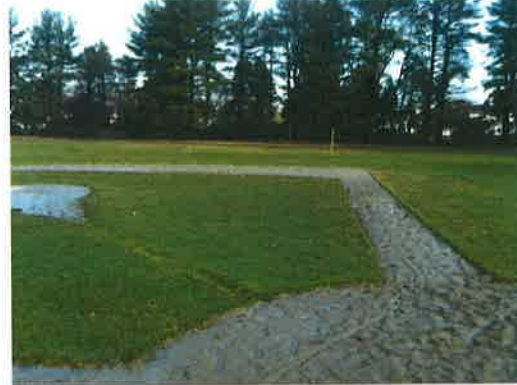
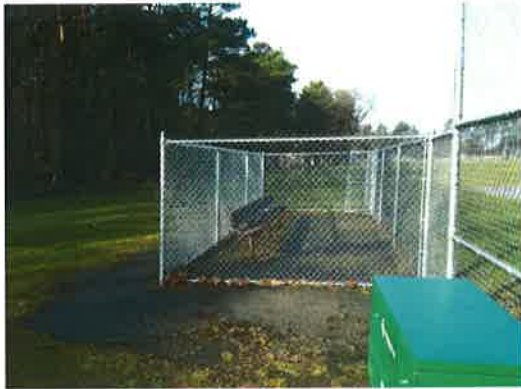
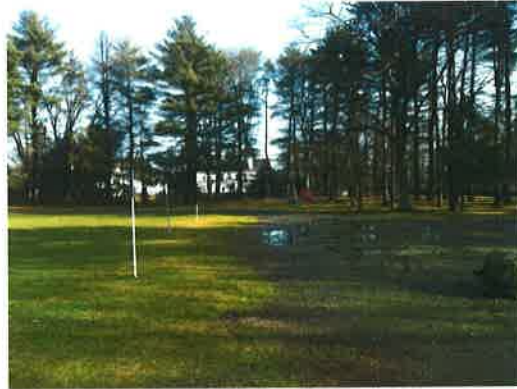
B. Photo Documents (Insert pertinent photos here):

1. Irrigation: **No**
  - a. Describe system (brand; age; water source; zones; controls; condition):  
unknown
  - b. Recommendations:
2. Does the field have existing drainage? **No**
  - a. If yes, what is the depth, spacing, size, backfill, and sleeved?
  - b. General condition/effectiveness:
  - c. Recommendations:

- b. Recommendations: Fencing in good condition.
5. Ancillary Equipment (describe general conditions):
  - a. pitchers mound and rubber - OK
  - b. bases and home plate – OK

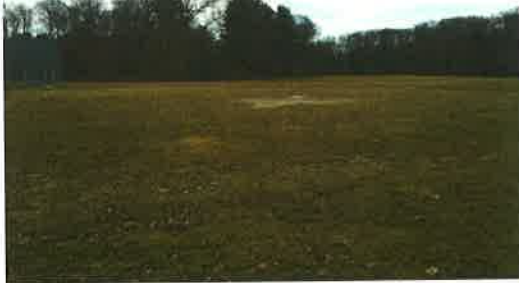
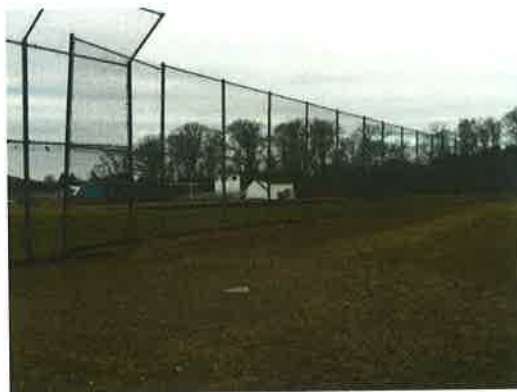
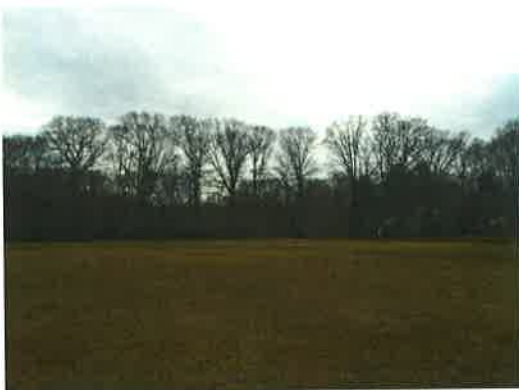
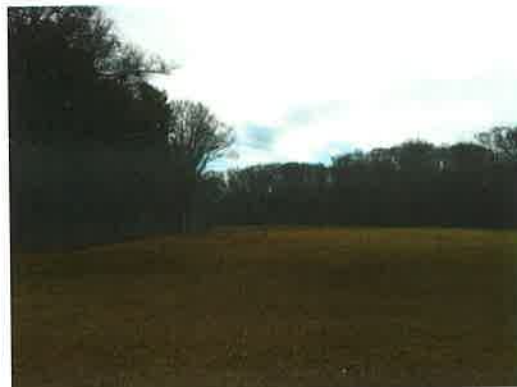
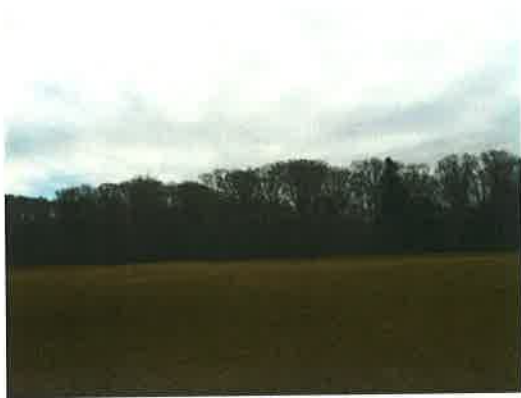
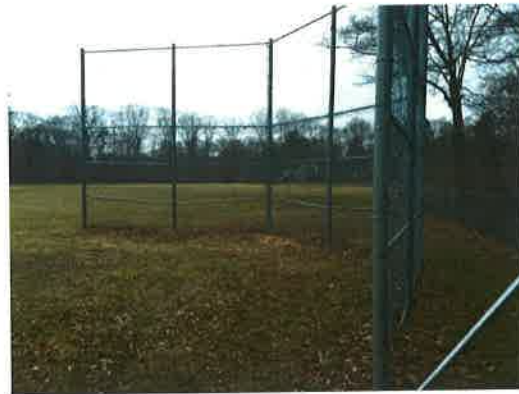
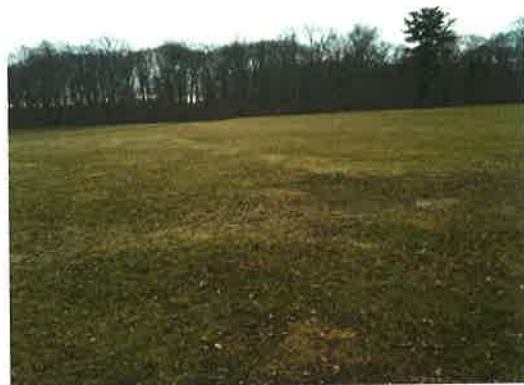
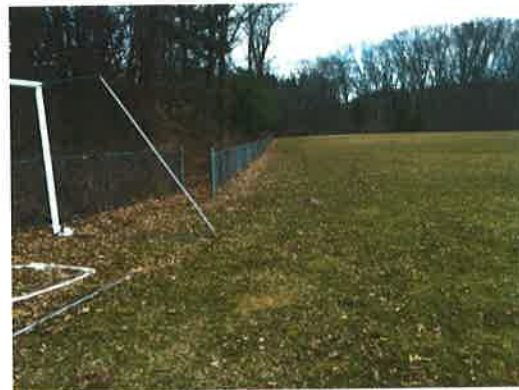
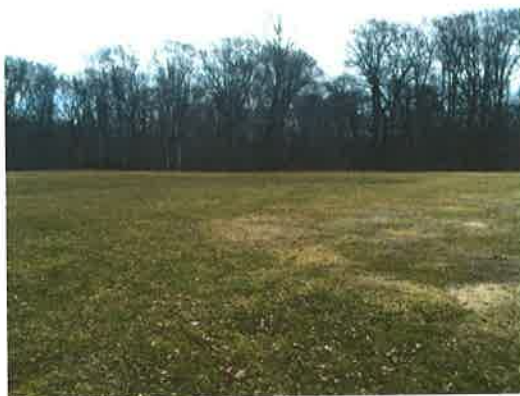
- B. Photo Documents (Insert pertinent photos here):

a. Describe Fencing System (make/model, age, type gates, foundations, condition, etc.): Backstop at baseball/softball fields in fair condition. 6' fencing along baseball baselines, 4' fencing along property line to South of Baseball field. 12' fencing dividing baseball and track areas. Additional fencing along field sideline areas is 4' chain link fencing in fair condition. Additional fencing recommended along wooded areas for safety/ball retrieval.

5. Ancillary Equipment (describe general conditions):
- a. pitchers mound and rubber – Poor condition. Baseball mound and batters box requires complete reconstruction.

- b. bases and home plate – fair condition
  - c. score boards – N/A
  - d. back stop – Fair condition. Softball backstop shall be removed as it is not used. Baseball backstop is in fair condition but is poor in visible appearance.

b. Recommendations: Additional fencing. Removal of backstop at 60' diamond.

- e. dug out(s) – N/A, Recommend fenced dugouts for player seating areas. Seating areas are not sufficient for players/equipment.
  - f. P.A. system – N/A
